Hilcorp Alaska, LLC

Re: Middle Ground Shoal Platform, Natural Gas Pipeline Release
Middle Ground Shoal Gas Leak Sampling and Monitoring Plan Summary Report
Sampling Period #6 ending 04/25/2017

Weekly Report #6

Prepared by SLR International Corporation (SLR)

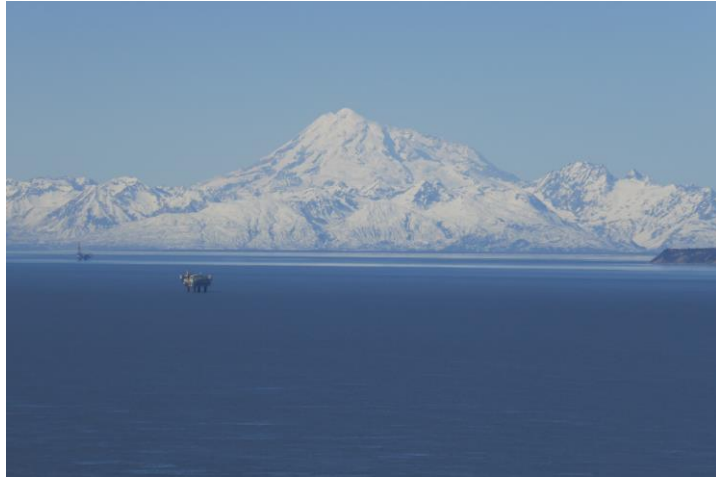
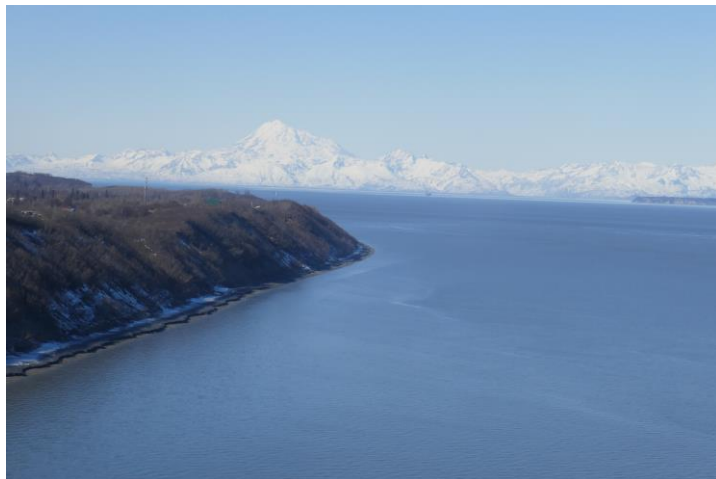
Photograph Log

Photos were taken the vicinity of the leak with a view of Platform A. Flight circles are approximately 0.5 miles apart. The still water has been conducive to detecting flight or dive movements of wildlife.

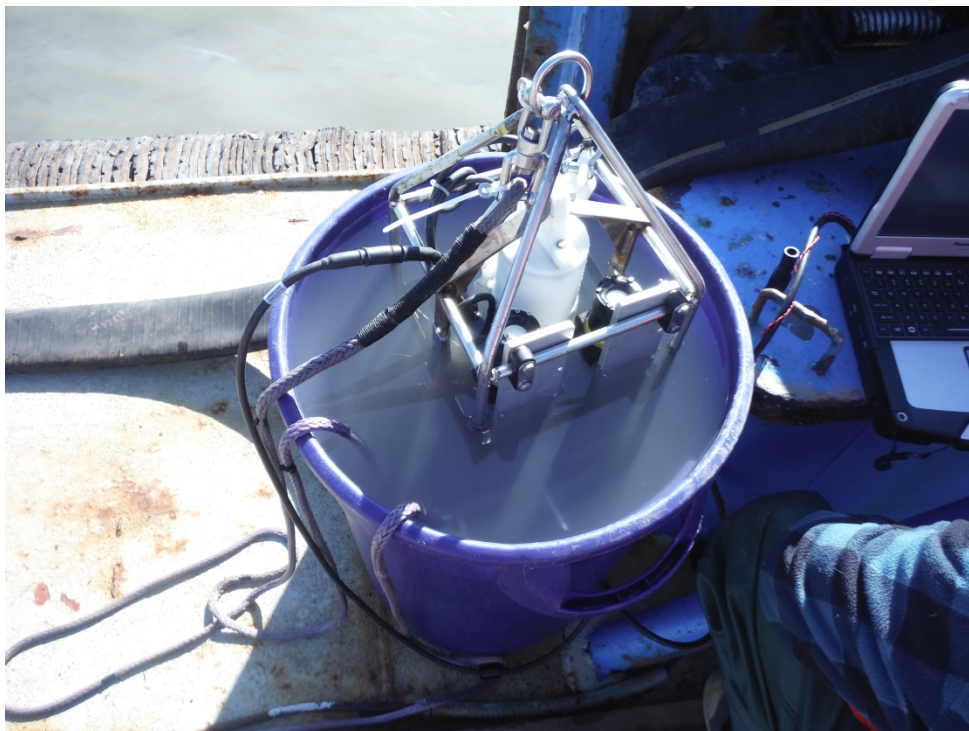
Photo 2: Instruments being kept in tub of seawater to keep them as close to in-situ conditions as possible.

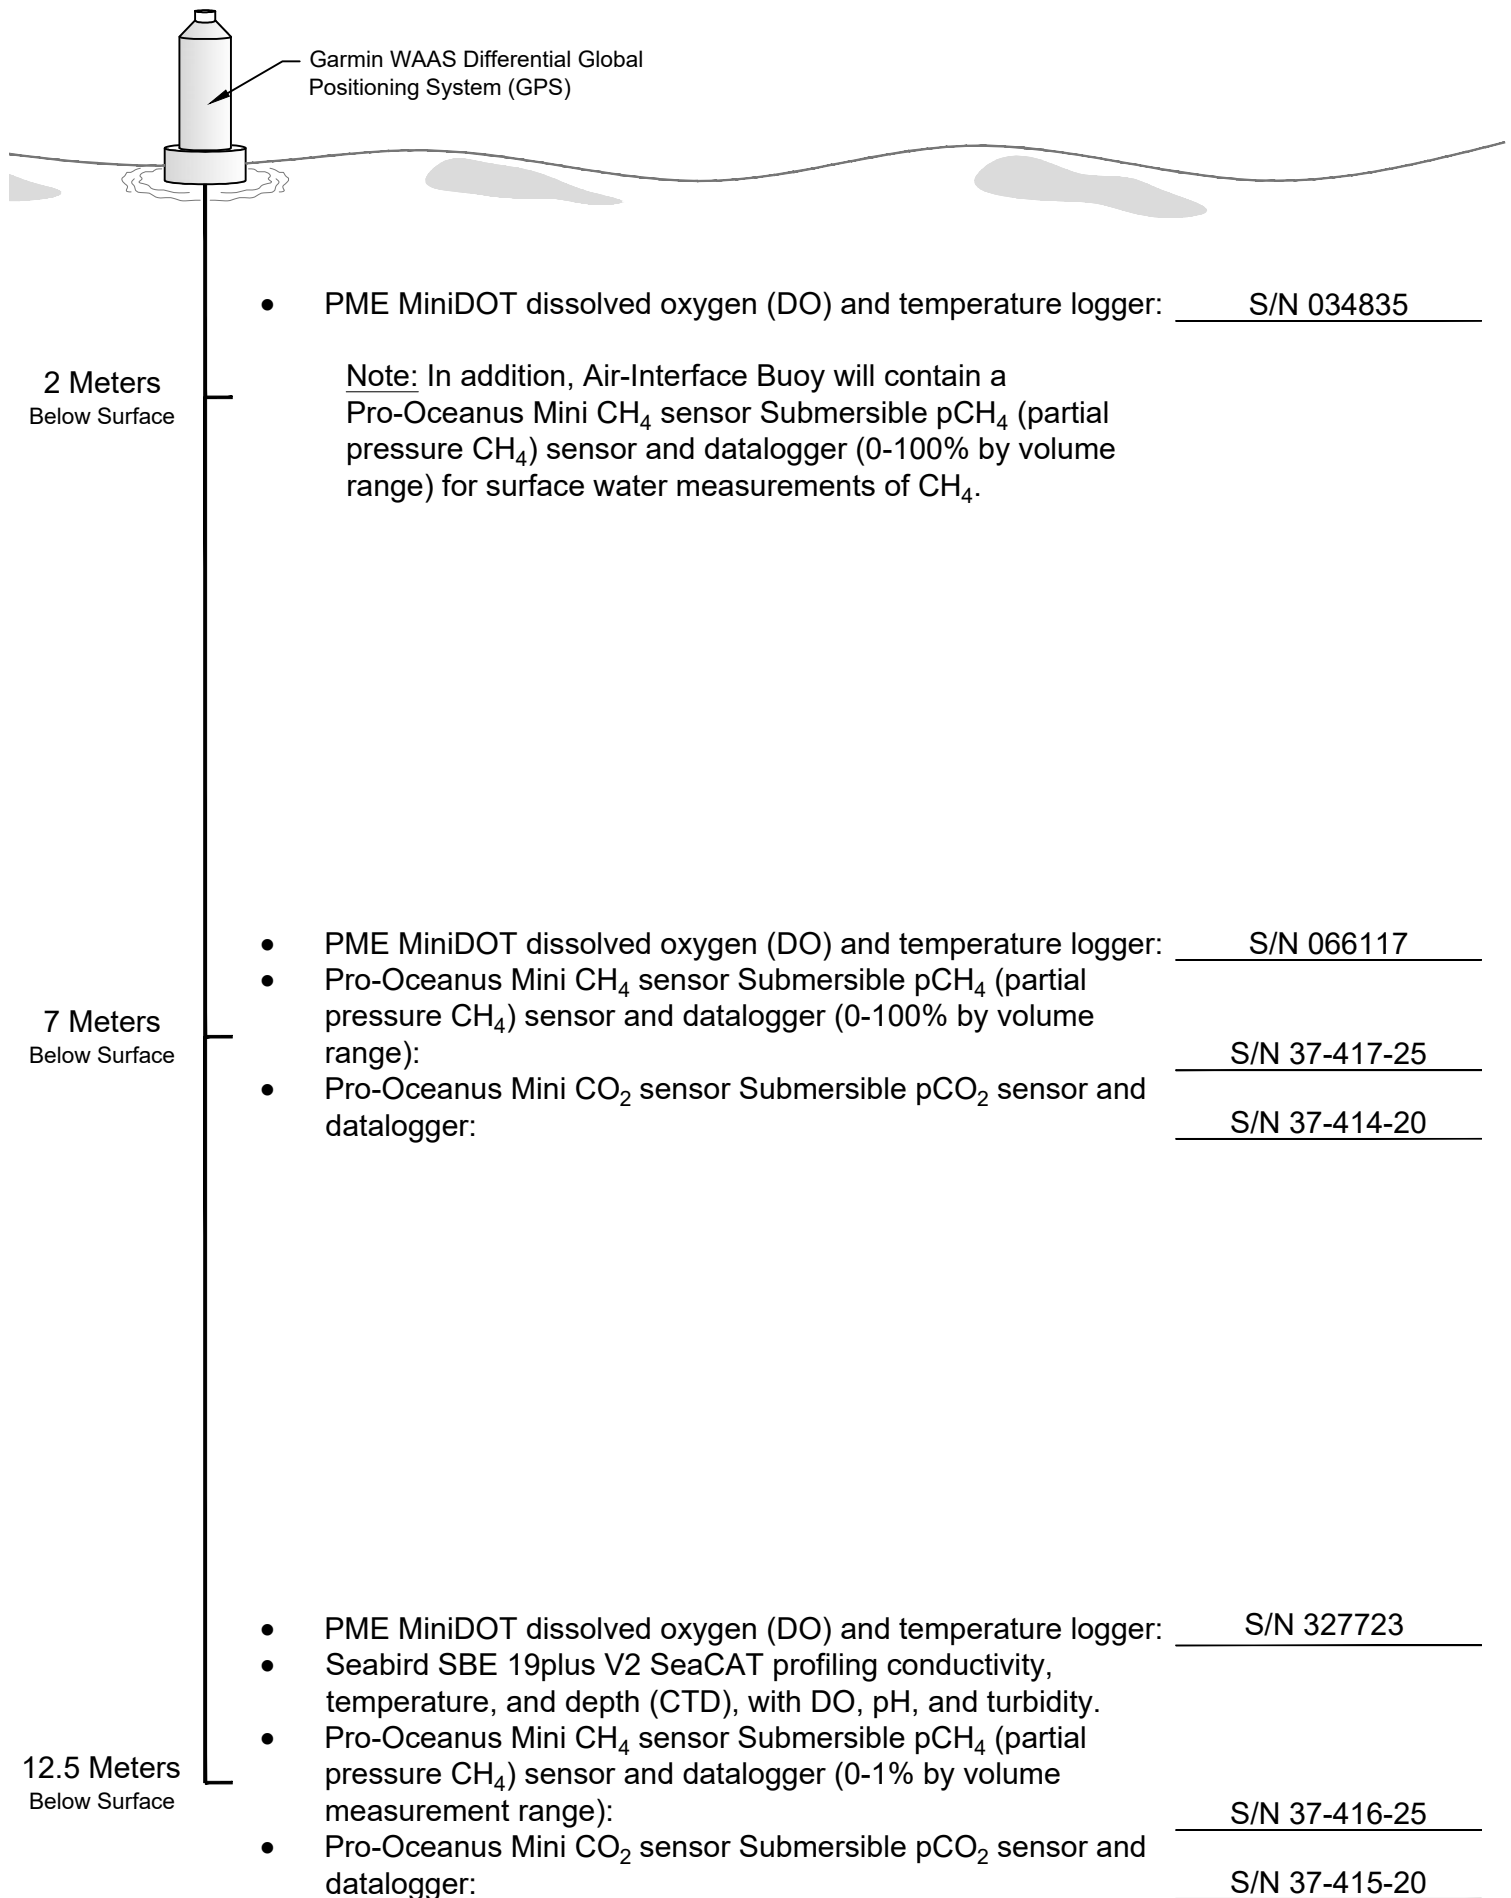
FIGURE 1: WATER QUALITY MONITORING BUOY SCHEMATIC
(MARCH 23, 29 and APRIL 5, 12, 19, 2017)

The data collection activities followed the Water Quality Cook Inlet Alaska Methane Pipeline Leak Water Quality Sampling Plan (WQ Plan), (SLR 2017a). The primary data collection method utilized a drifting instrumented buoy to obtain water quality parameters in the area of interest. The drifting buoy had multiple instruments suspended along a line at three depth intervals (2, 7 and 12.5 meters) as depicted on Figure 1. The primary instruments are listed below:
